KIRK SYSTEM 500

SERVICE NEWS 074

Release of New flash-software for KIRK System 500

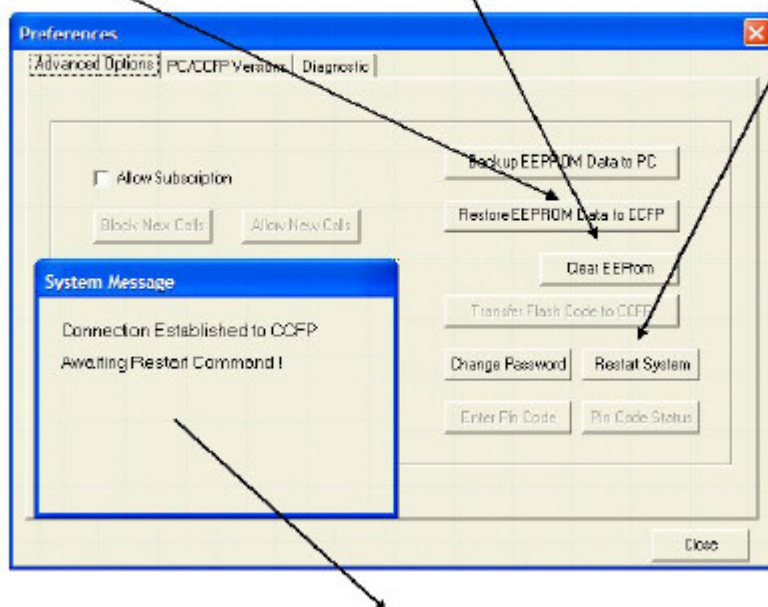
The software-reset function is disabled in the software version 1N.
In situations where the CCFP Adm. Program is expecting a software reset e.g. after "Clear EEPROM", "Restore Data to CCFP" and "Restart System" a restart of the CCFP Adm. Program is necessary.
The system 500 must be reset by a power-reset in the above mentioned situations as well - Power Off/On.

Restore EEPROM Data to CCFP

Clear EEPROM

Restart System
