# Release Notes

Polycom® HDX® Systems, Version 3.0.3

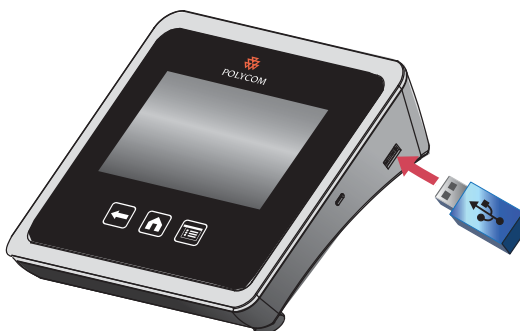
The Polycom Touch Control with version 1.2.0 software allows you to show content from a USB drive. You can open documents (.pdf), slide shows (.pptx), images (.bmp, .gif, .jpg, .png). You can also annotate files while showing them to far sites. For more information, refer to the *User Guide for Polycom HDX Systems and the Polycom Touch Control*. This is an experimental feature and is not yet supported.
