# Release Notes

Polycom® HDX Systems, Version 2.5.0.5

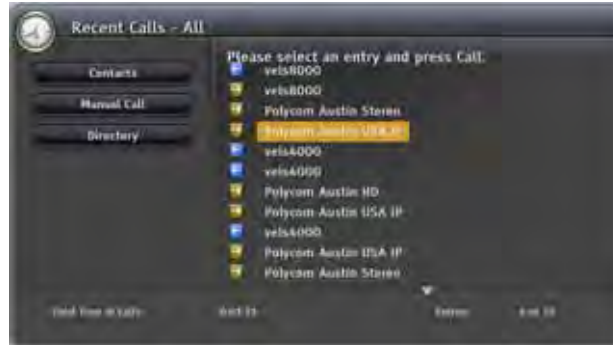
## Recent Calls Screen

The Recent Calls screen has been redesigned with functionality similar to the Contacts home screen.

From the Recent Calls screen you can navigate to the Contacts list screen, Place a Call screen, or the directory. You can also add recent calls to your Contacts list.

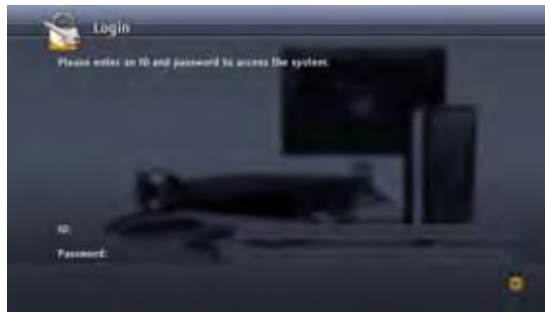
### Login and Logout

In version 2.5 you can require users to log in for system access. Version 2.5 also adds a logout feature. If **Require Login for System Access** is enabled, the system automatically prompts users to log in when the system comes out of sleep mode. If a call comes in, the user must log in before answering the call, even if the system is configured to answer calls automatically.

When you log in, the system displays the time and date of the last successful login to the account, along with the number of unsuccessful login attempts since that time.
